Evaluating Streetscape Modifications in Los Angeles, California with a Health Lens

Gabrielle Green¹, Lauren N. Gase¹, Chandini Singh¹, and Tony Kuo^{1,2,3,4}

¹*Division of Chronic Disease and Injury Prevention,
Los Angeles County Department of Public Health*

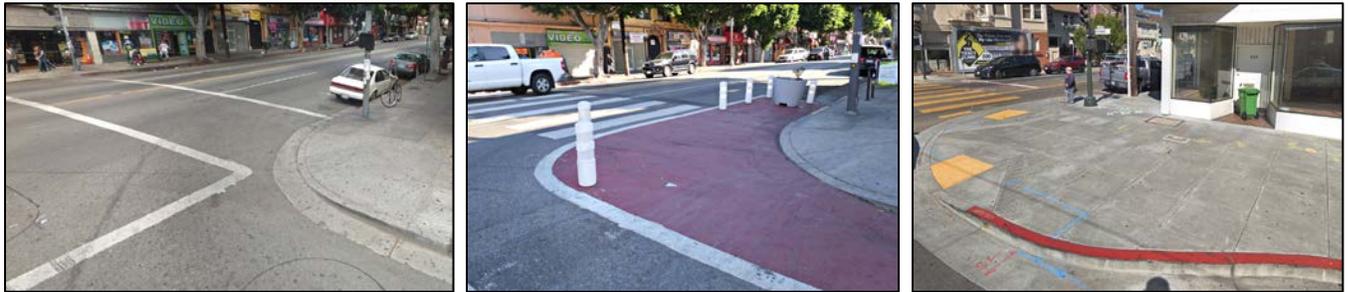
Figure 1. Intersection of St. Louis and César Chávez Avenue before (far left) and after (middle) installation of a painted curb extension, compared to a concrete curb extension (far right).

A curb extension is a physical extension of a curb at a corner that is intended to reduce the pedestrian crossing distance, increase visibility between pedestrians and motorists, and reduce the speed of turning vehicles, all of which may increase pedestrian safety and encourage motorists to drive more carefully (Huang & Cynecki, 2001; National Association of City Transportation Officials, 2017). Curb extensions are typically made of concrete, but the curb extensions installed on César Chávez were created by using red paint on the portion of the street where a concrete curb extension would be, bordering the extension with white paint and flexible bollards, and adding planters in the extensions (Figure 1). Research specifically on painted curb extensions is limited, and existing research on concrete curb extensions has produced mixed evidence on whether the extensions can improve pedestrian safety (e.g., by reducing pedestrian-motorist collisions at intersections) (Huang & Cynecki, 2001; King,
